STATE OF MARYLAND
BOARD OF NATURAL RESOURCES
DEPARTMENT OF GEOLOGY, MINES AND WATER RESOURCES
JOSEPH T. SINGEWALD, JR., *Director*

BULLETIN 6
SHORE EROSION
IN
TIDEWATER MARYLAND

1949

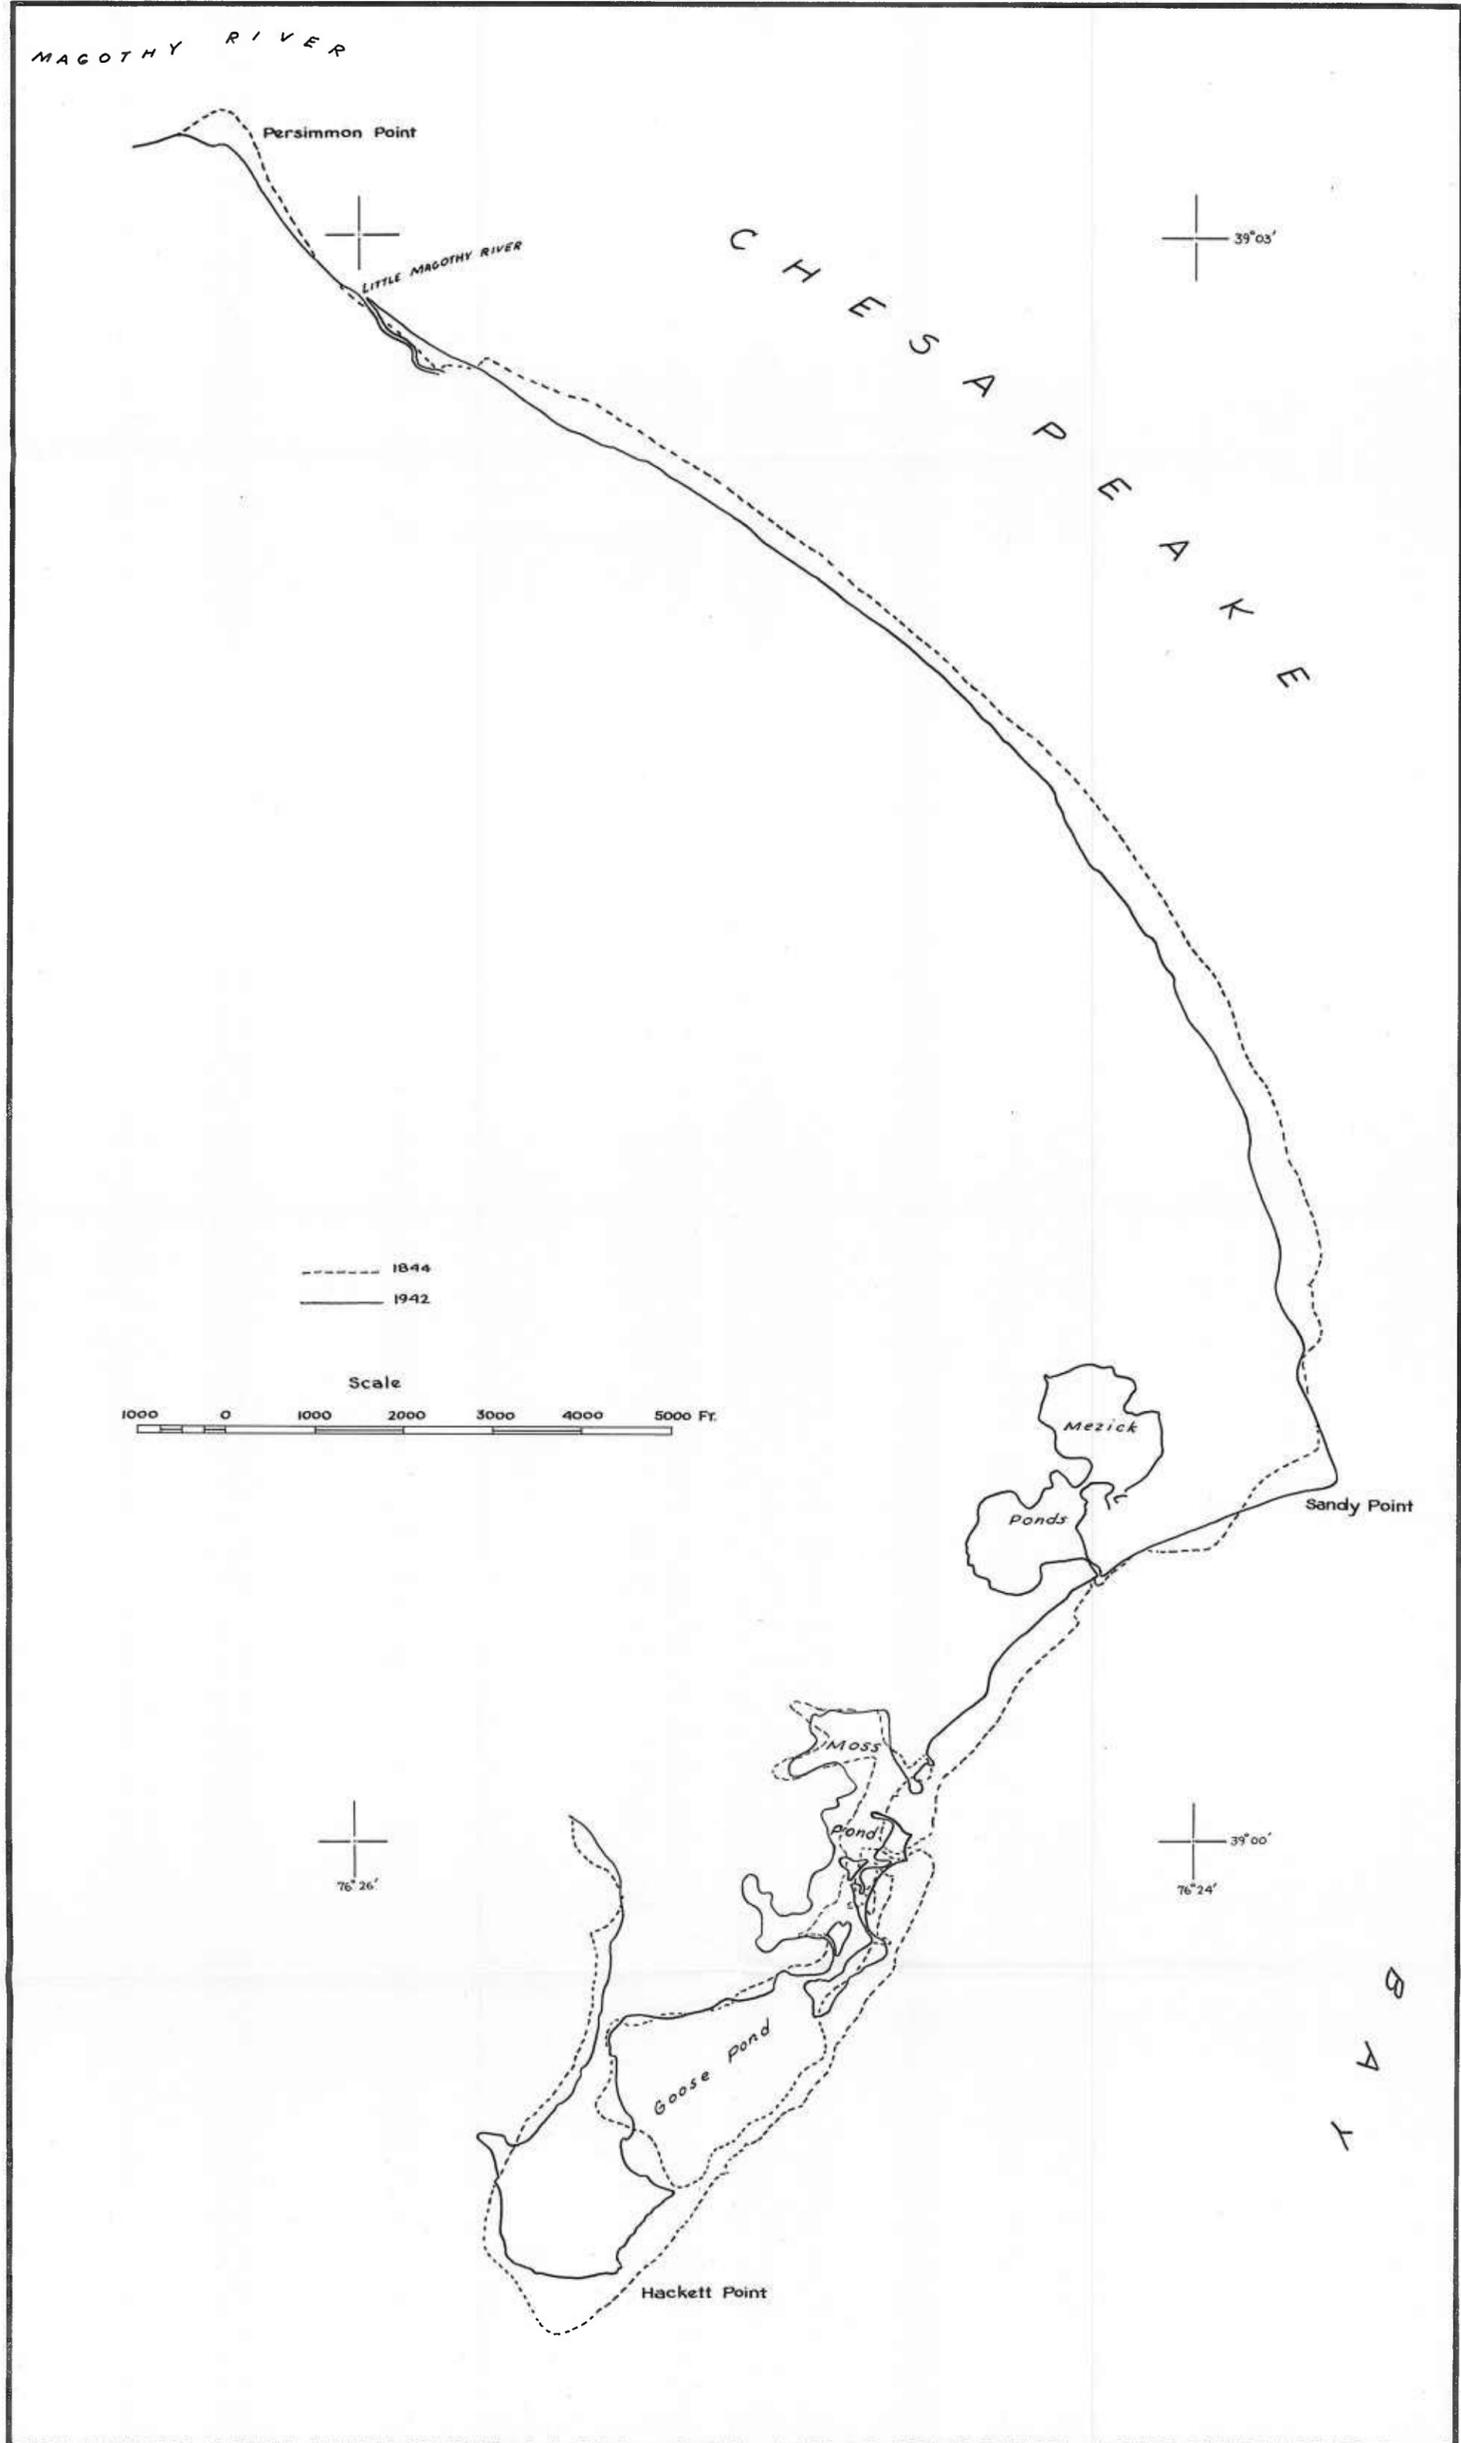
PLATE 2. Shore Line Changes from Persimmon Point to Hackett Point, Anne Arundel County

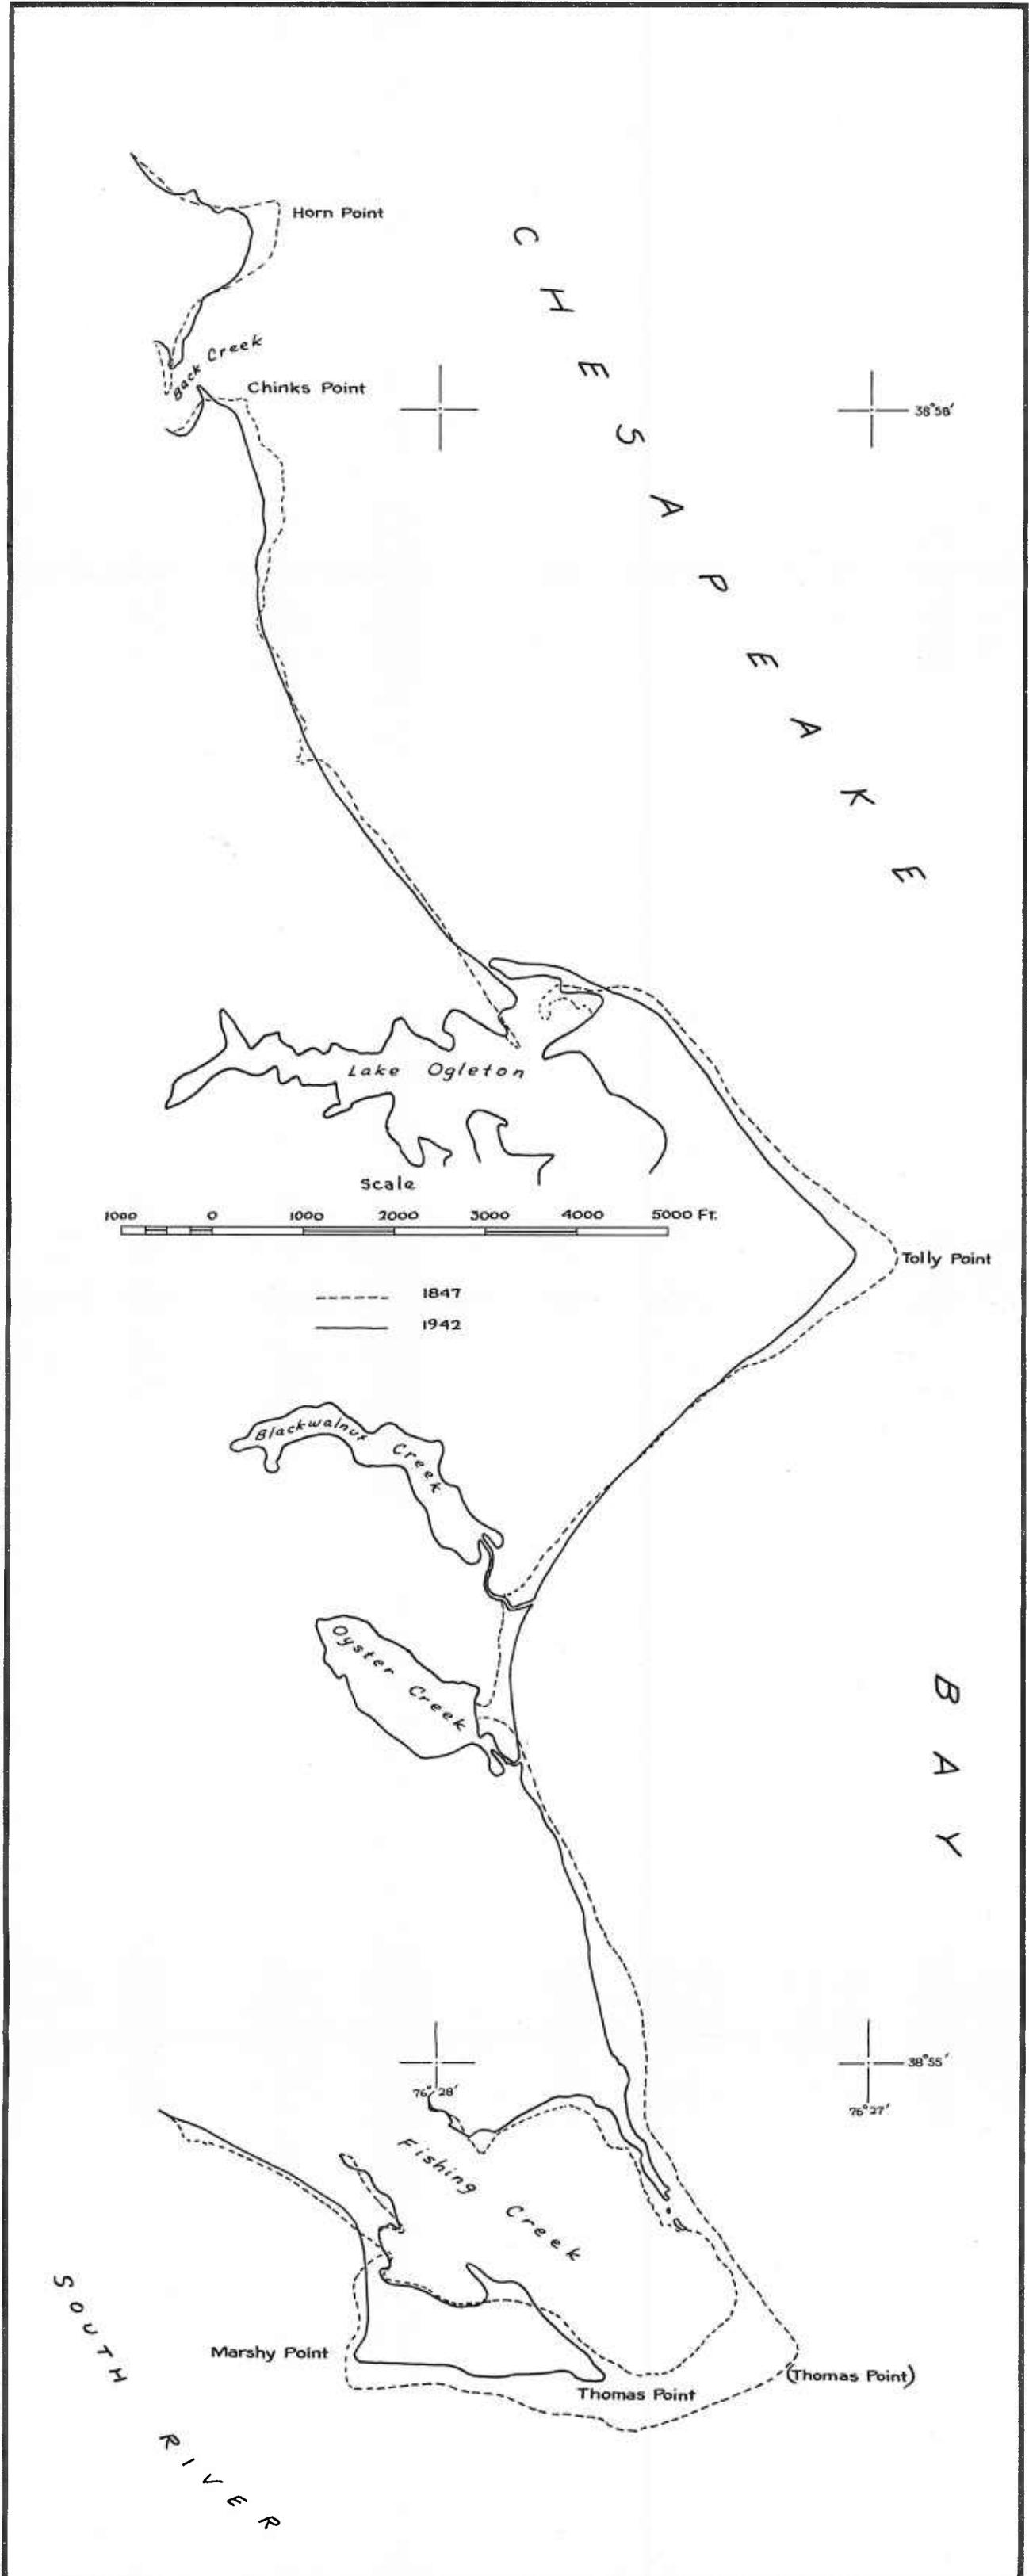
PLATE 3. Shore Line Changes from Horn Point to Marshy Point, Anne Arundel County

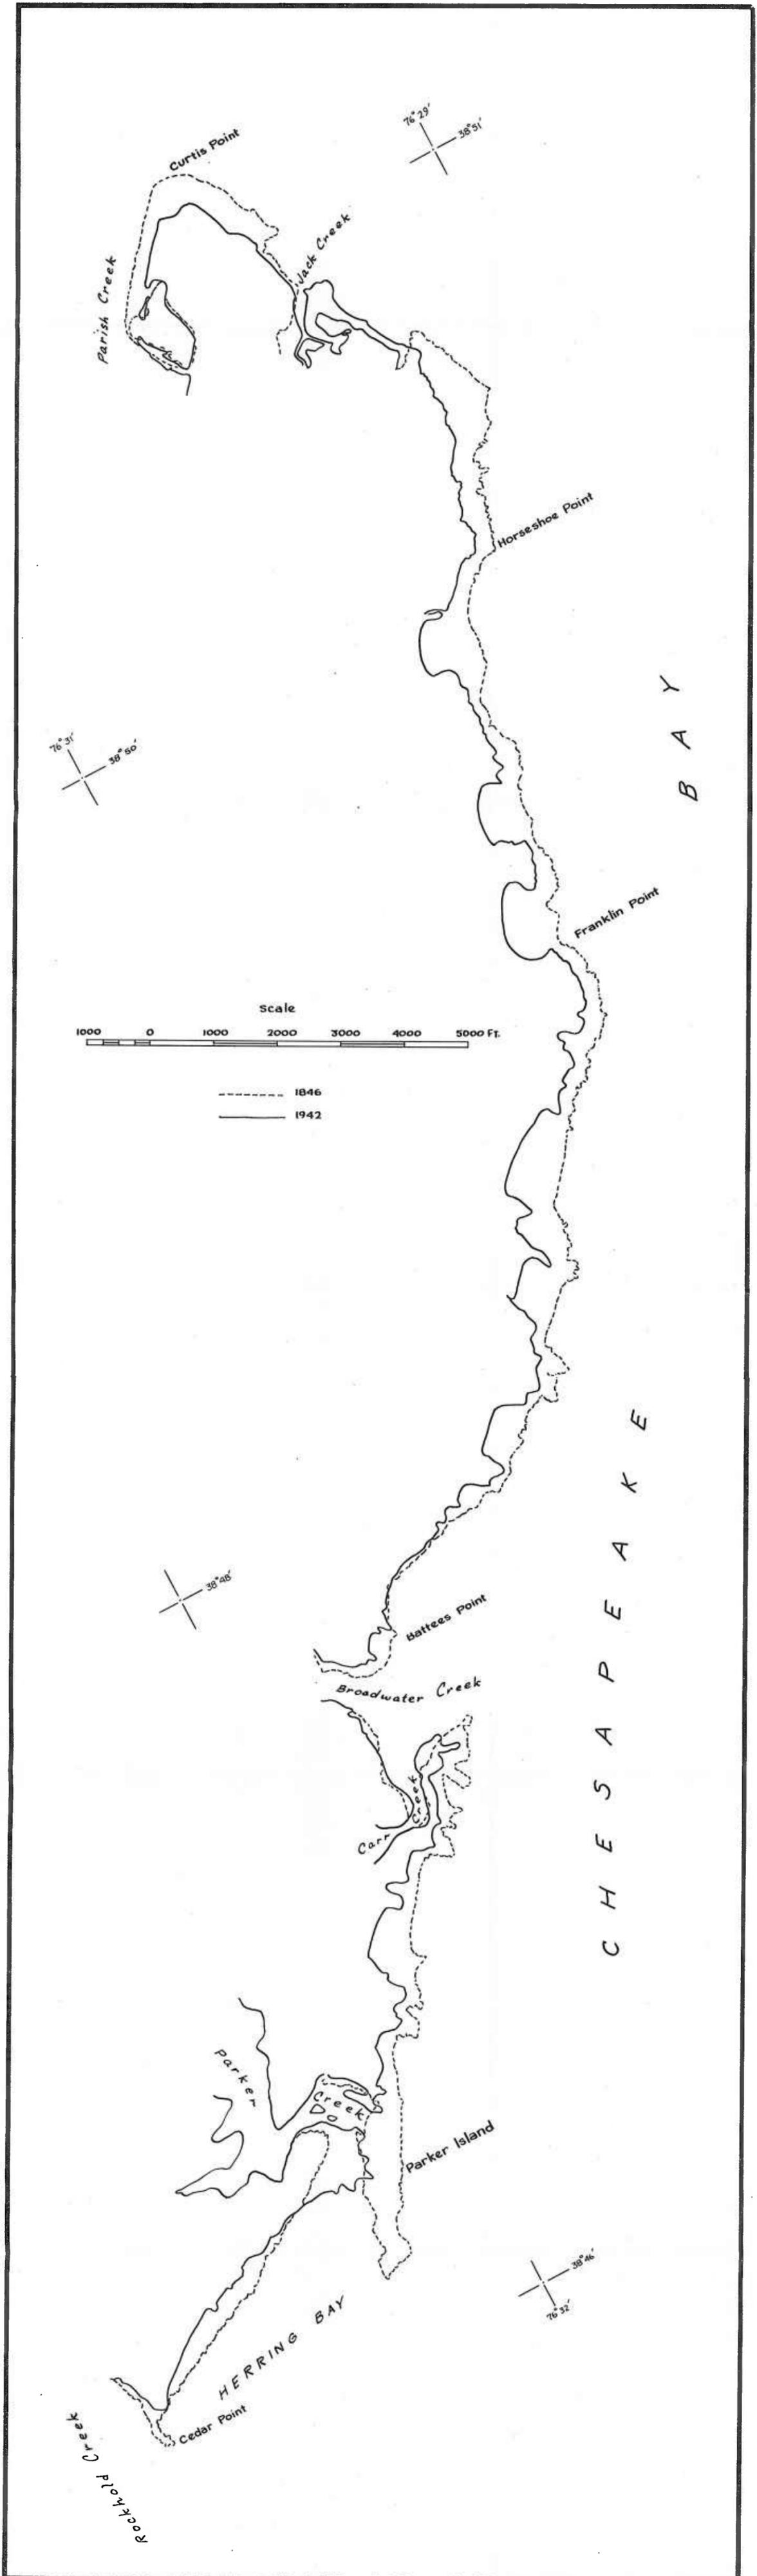
PLATE 4. Shore Line Changes from Curtis Point to Rockhold Creek, Anne Arundel County

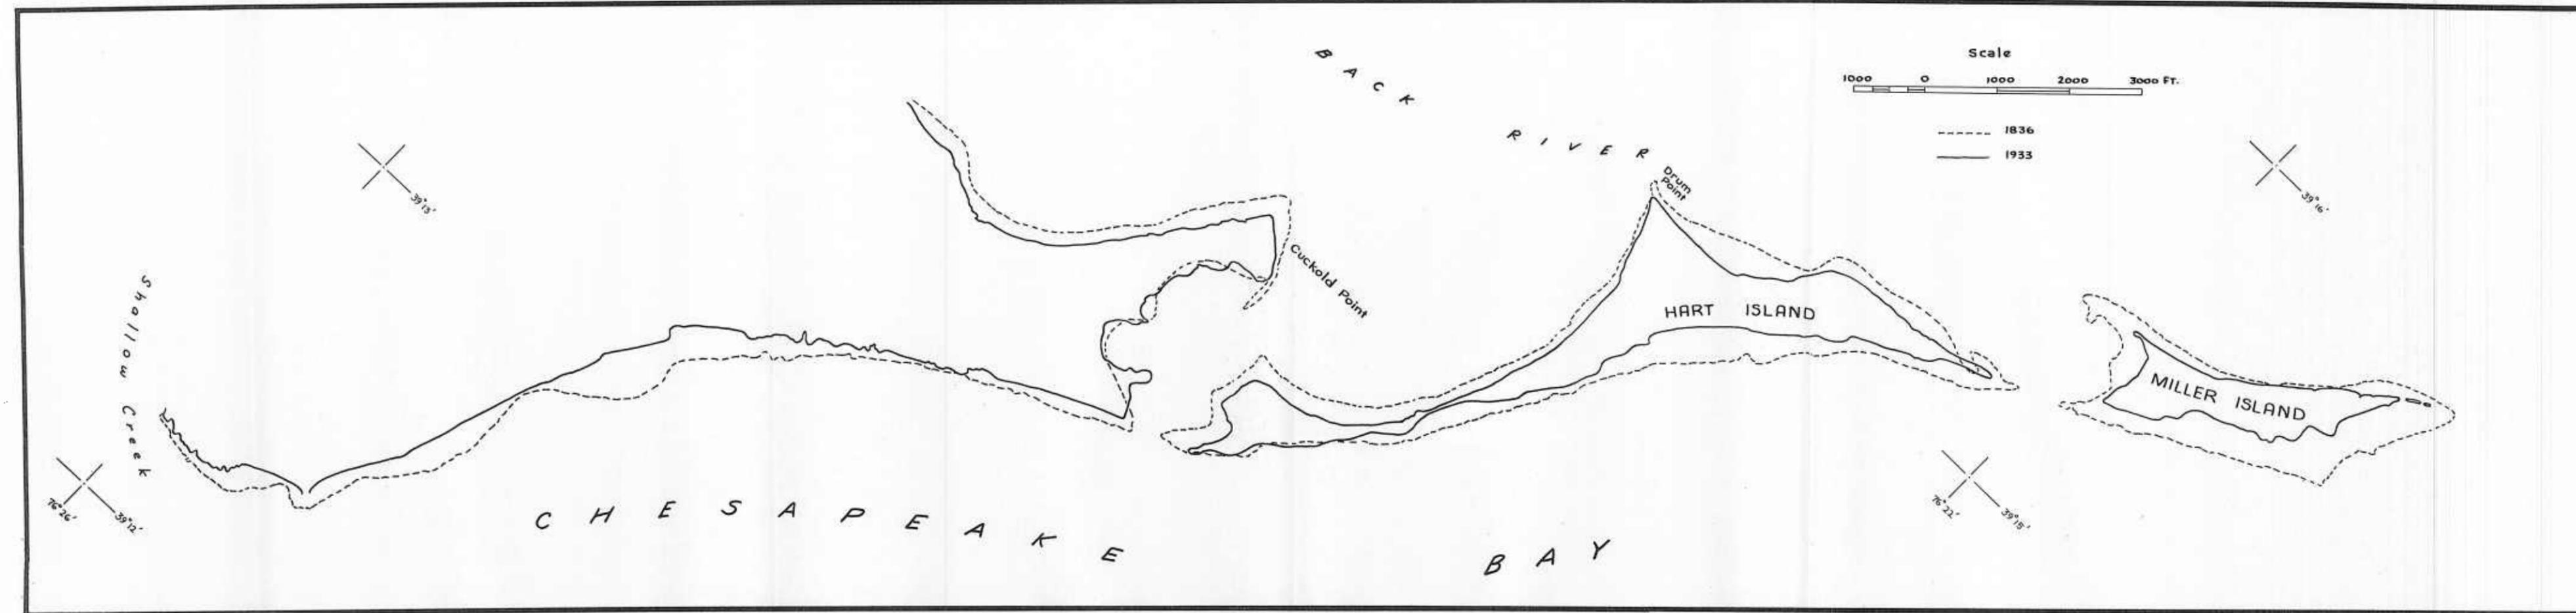
PLATE 6. Shore Line Changes from Cuckhold Point to Shallow Creek, and on Hart and Miller Islands, Baltimore County

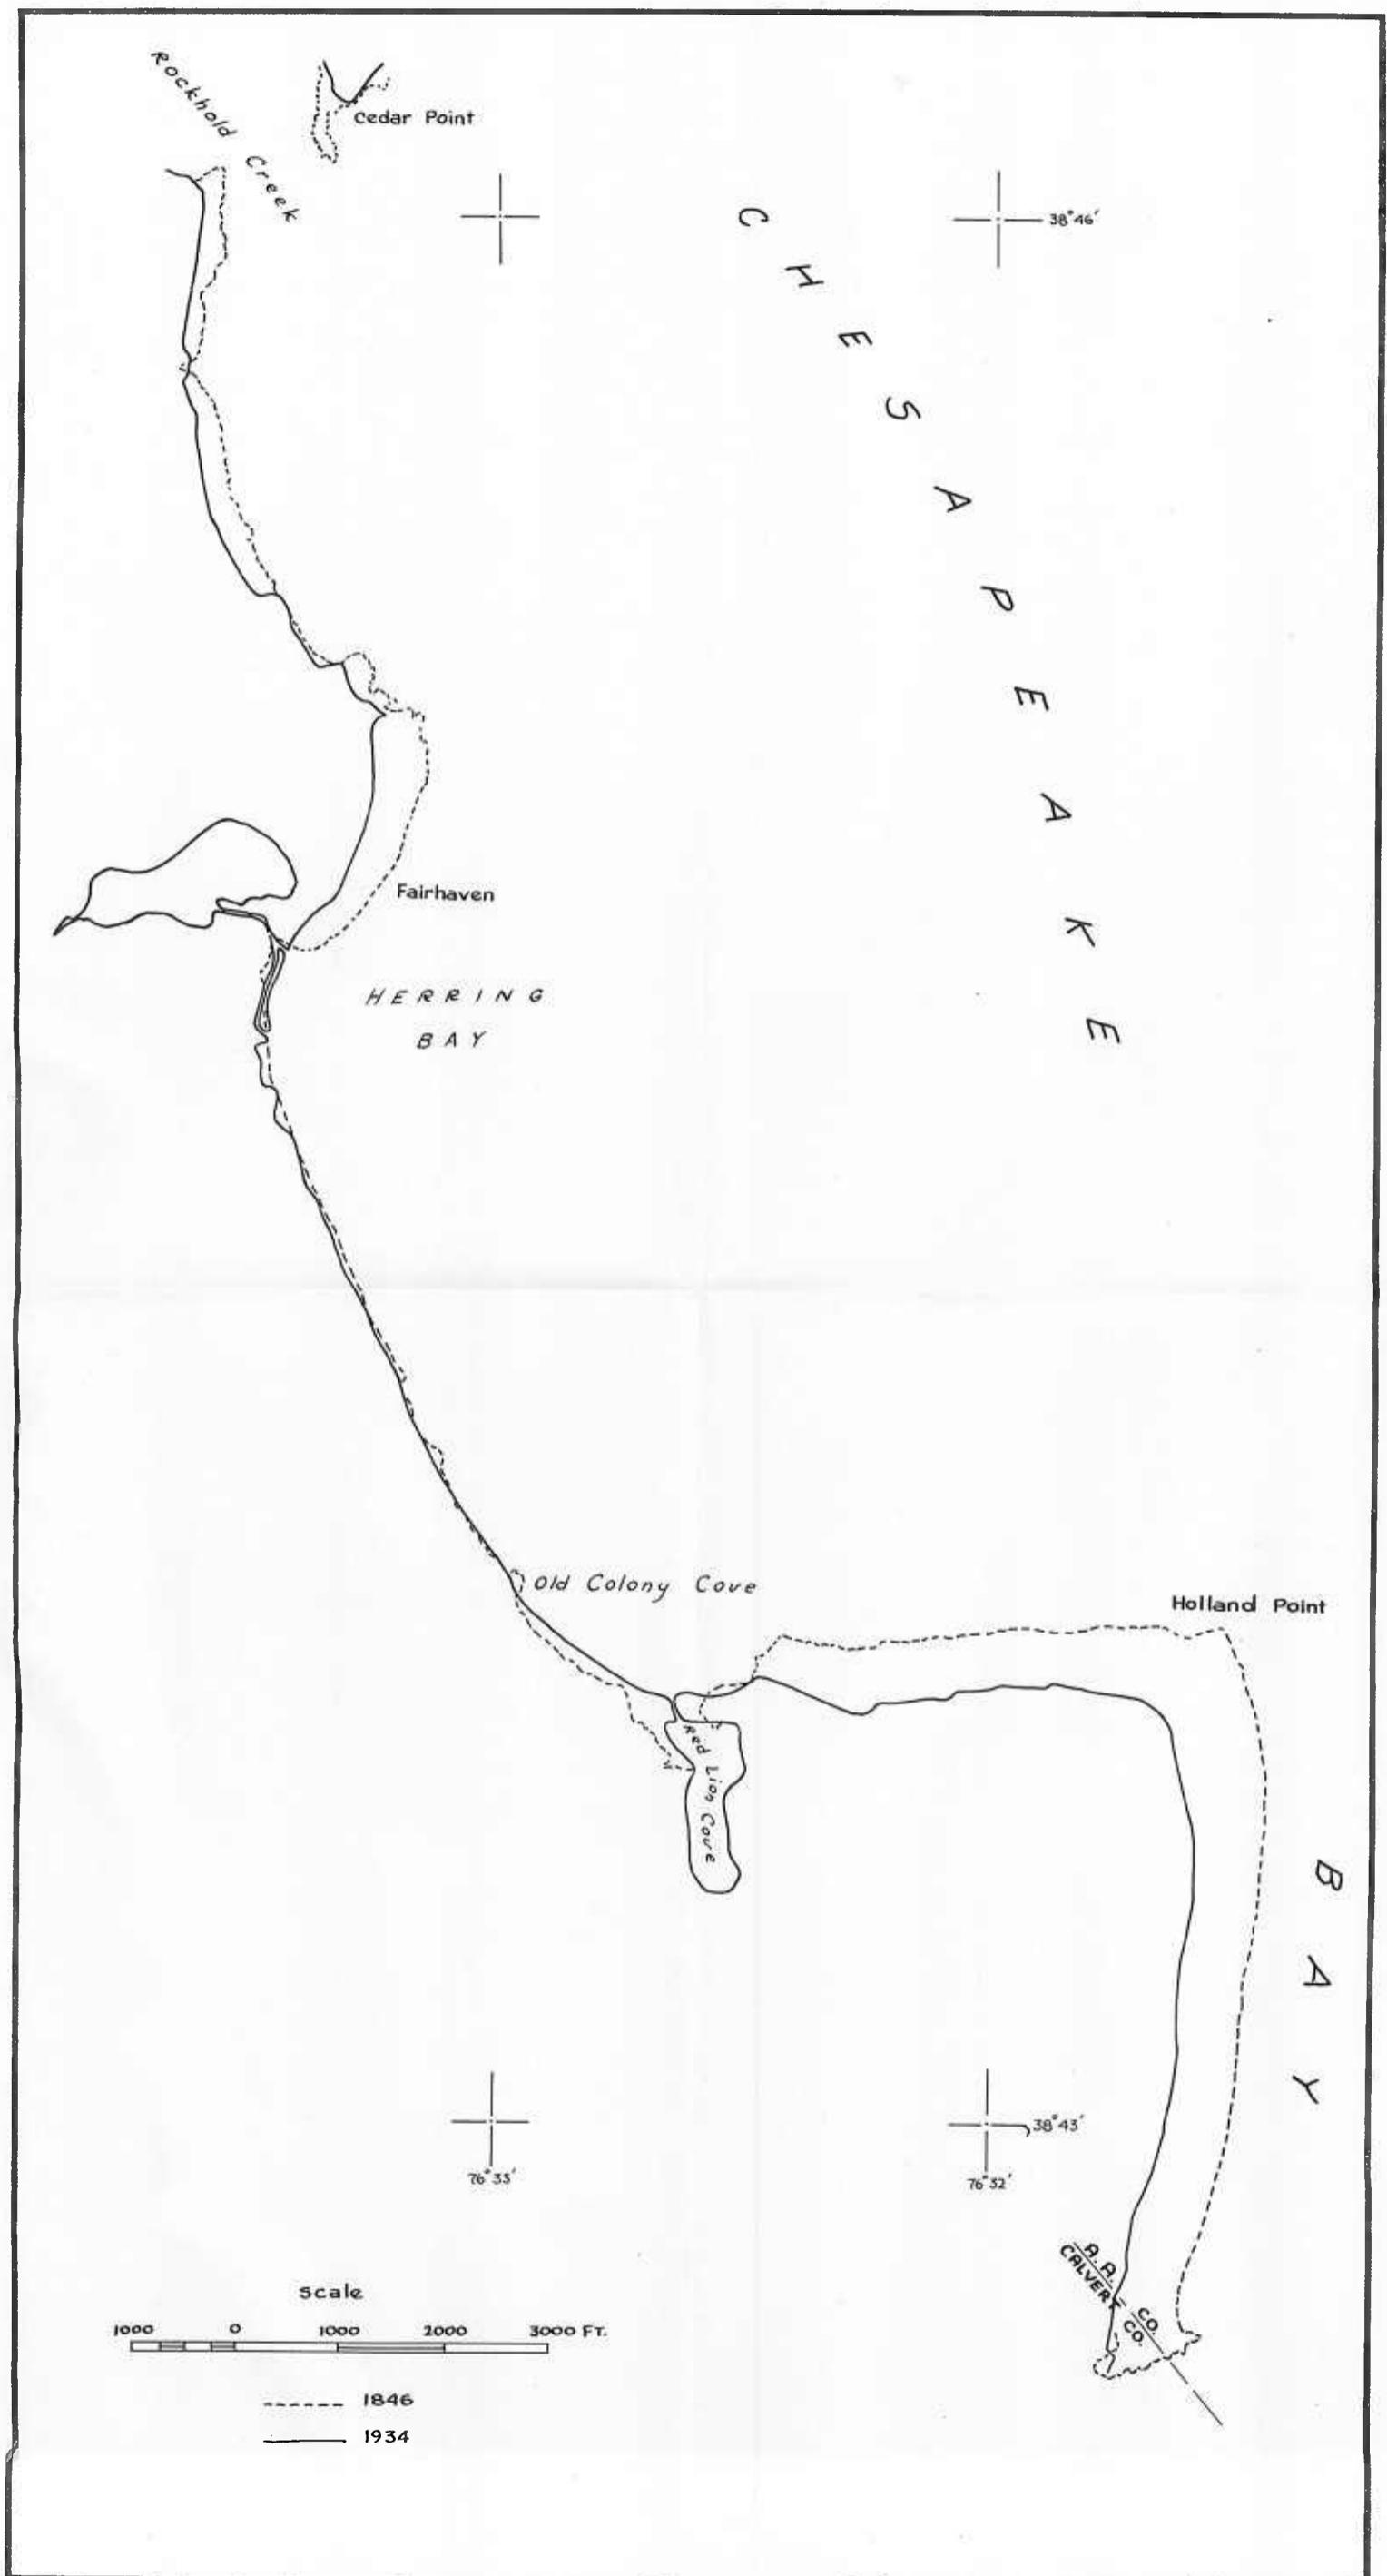
PLATE 5. Shore Line Changes from Rockhold Creek to the Anne Arundel-Calvert County Boundary

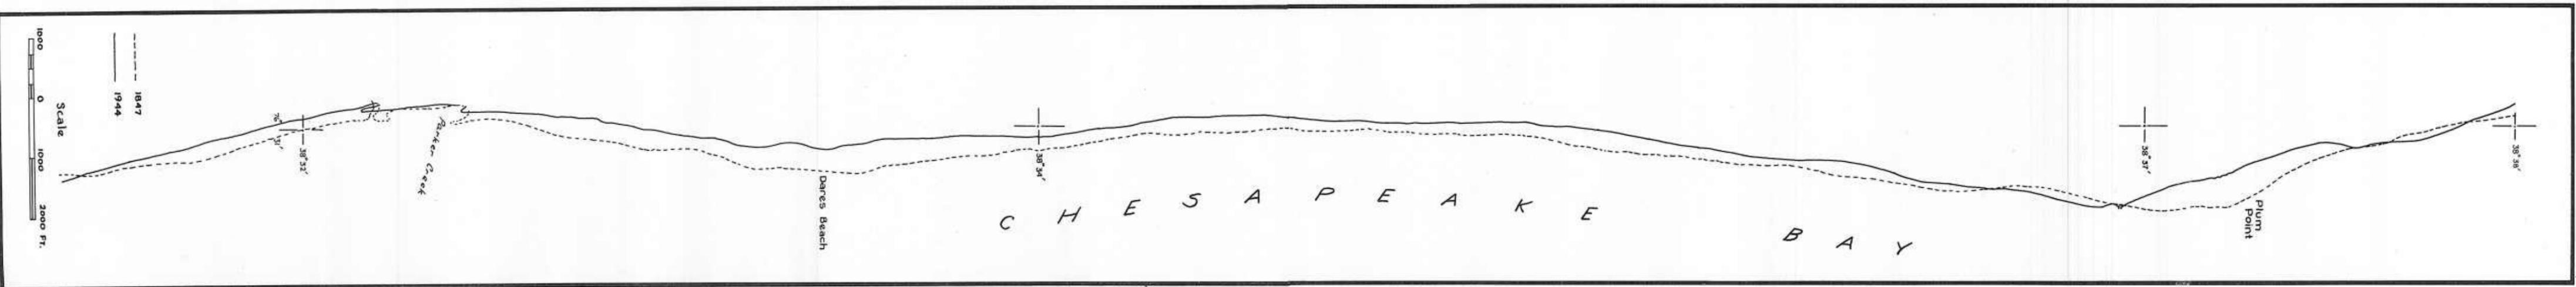
PLATE 7. Shore Line Changes from Latitude 38°38'N
to 1 1/4 Miles South of Parker Creek, Calvert County.

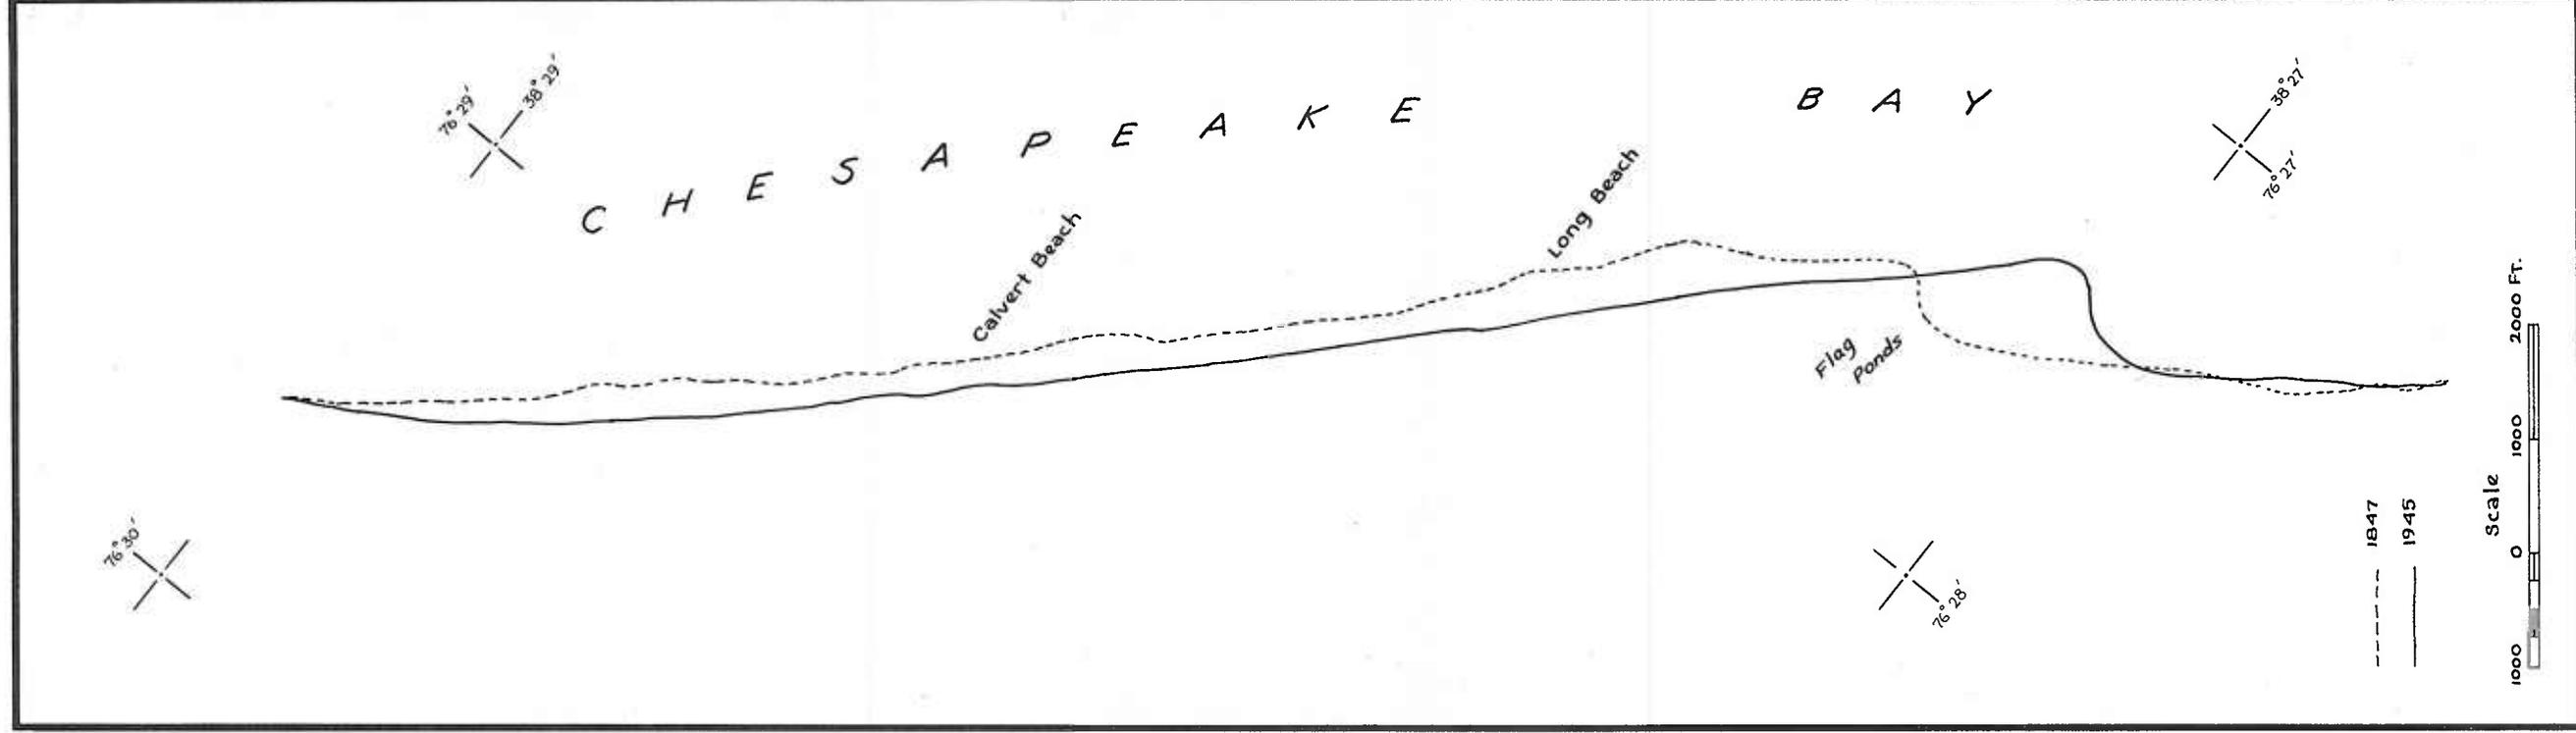
PLATE 8. Shore Line Changes from Latitude 38°29'N to 1 Mile South of the Flag Ponds, Calvert County

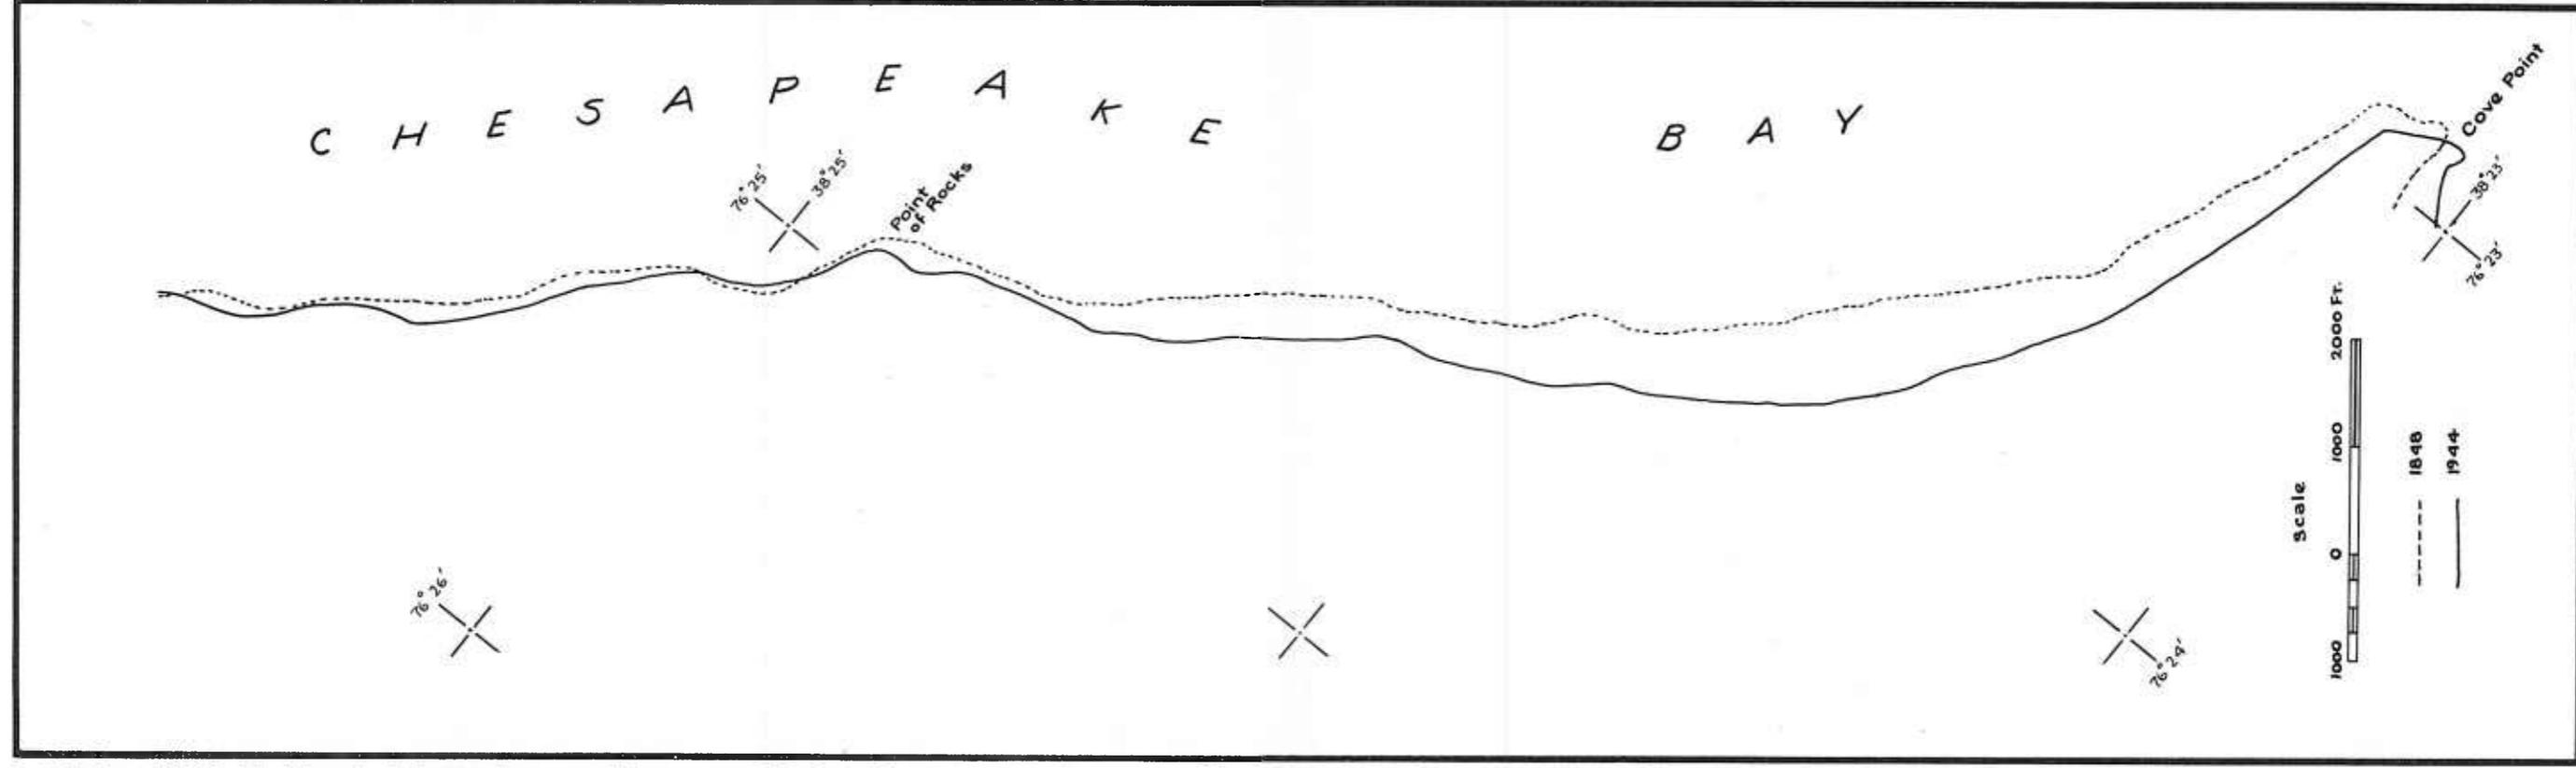
PLATE 9. Shore Line Changes from 1 Mile North of Point of Rocks to Cove Point,
Calvert County

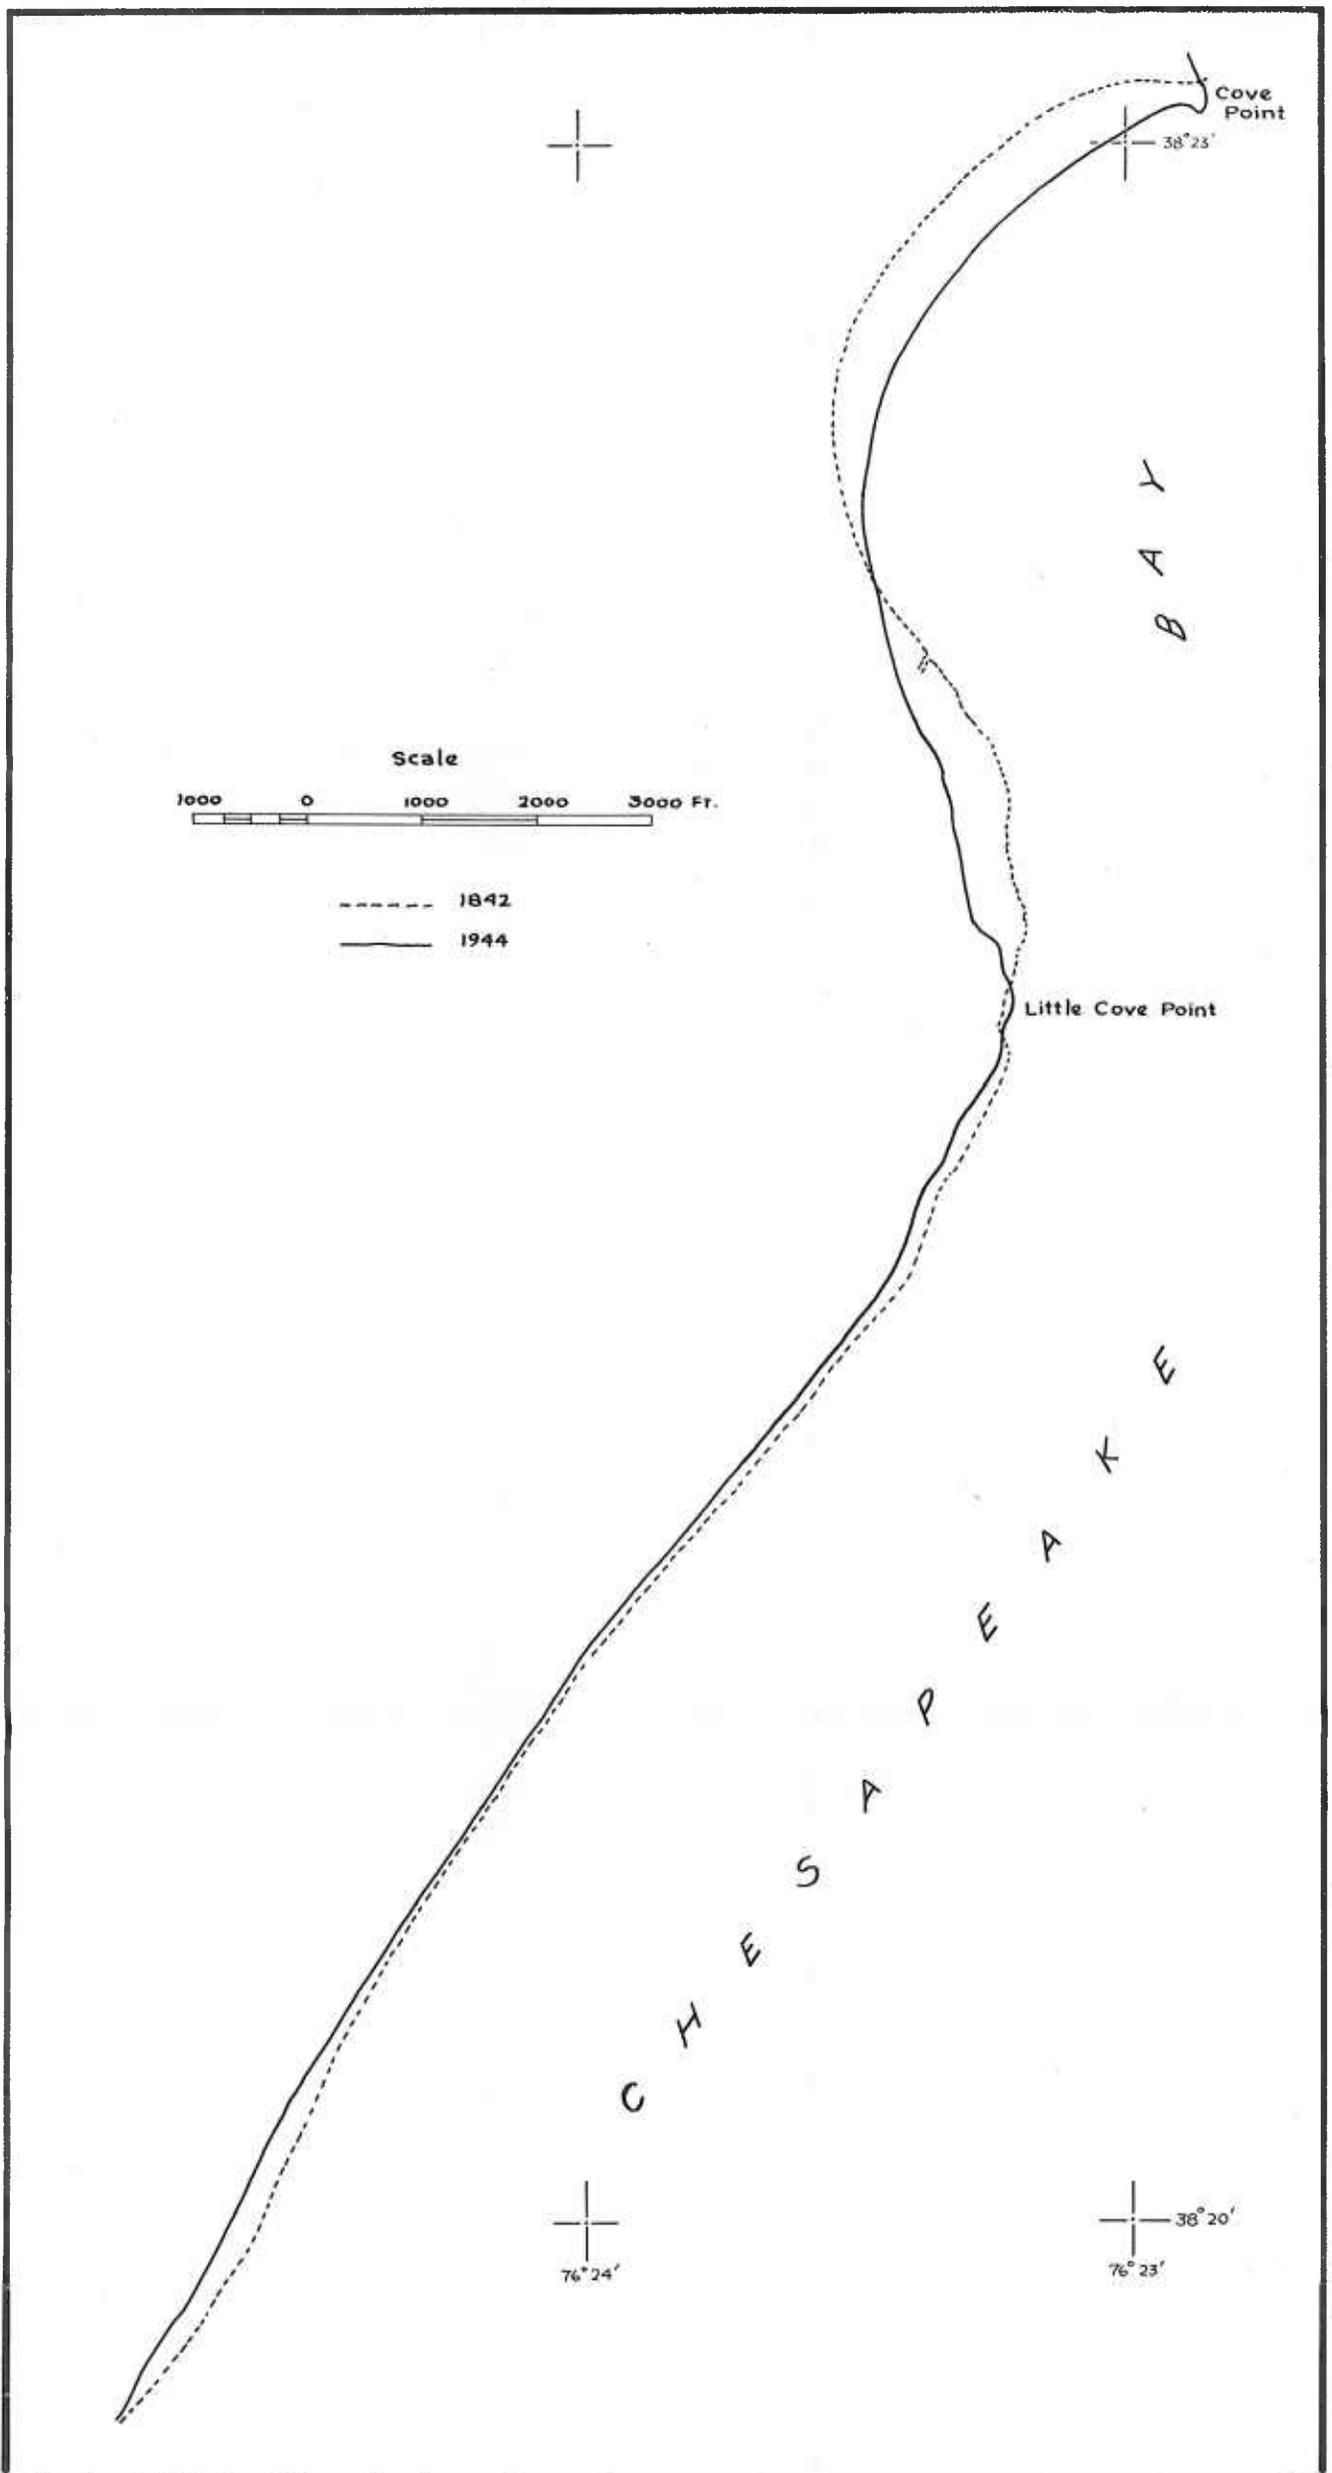
PLATE 10. Shore Line Changes from Cove Point to $2\frac{3}{4}$ Miles South of Little Cove Point, Calvert County
